Sebalog HydroCorr Correlating noise loggers with hydrophone sensors

Leak location in a DN 900 grey cast iron water main

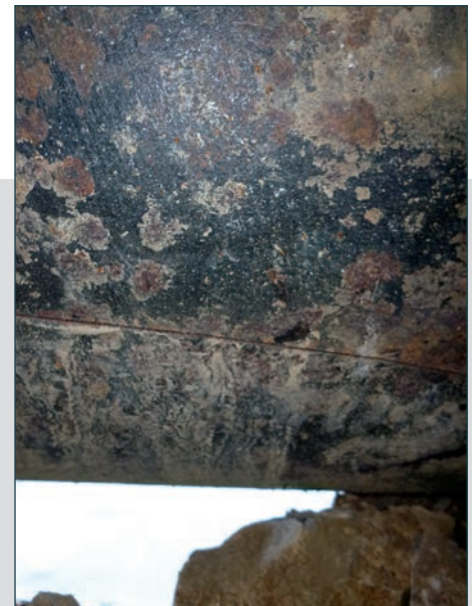
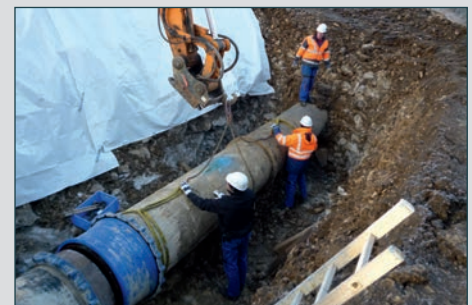
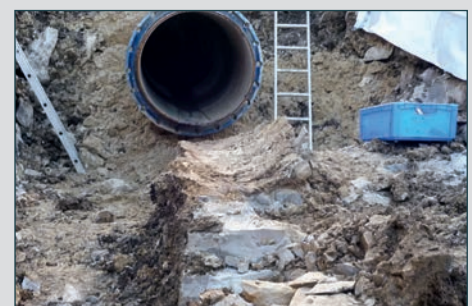
Although the pressure in the pipe was only around 1.5 bar, it was possible to carry out a successful measurement and receive a definite correlation result. The following pipe excavation confirmed the correlated leak location, revealing a 5 metre-long crack in the bottom of the pipe.

In mid-November, flow measurements by the regional water supplier in Stuttgart revealed the likelihood of a major leak in a DN 900 grey cast iron water main. Pressure measurements were carried out along the pipeline and the location of the suspected leak was narrowed down to a section of approximately 250 metres. To find the exact position of the leak, a Sebalog HydroCorr system was used, consisting of correlating noise loggers with hydrophone sensors.
